Cost Efficient Options and Financing Mechanisms
for nearly Zero Energy Renovation
of existing Buildings Stock

DELIVERABLE 2.3

REPORT SUMMARIZING OBSTACLES, RISKS AND DIFFICULTIES FOR THE RENOVATION SCHEMES

Municipality of Coimbra, Portugal

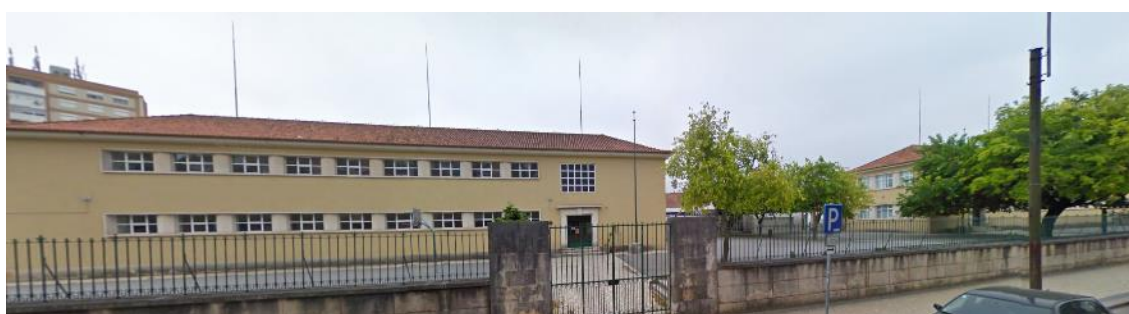
FIGURE 1: ELEMENTARY SCHOOL OF SOLUM

The Elementary School of Solum (Escola Básica do 1º Ciclo da Solum) was built in the 1950s. Until the 1970s this was an annex school to the teacher training colleges dedicated to pedagogical training. In the 1990s it was converted into an Elementary School. The construction of refectory and a partial renovation of the building was done 10 years ago. Figure 1 presents the front façade of the building. The building is located in the East side of the city, near to the Stadium and a commercial area.

The building is divided in 3 main areas: 2 blocks of classrooms and the refectory. It has total area of about 1655 m² (756 m² in each block and 142 m² in the refectory) and a volume of 6269,21 m³ (2828,19 m³ in each block and 612,84 m³ in the refectory). The roof is of ceramic tile and has a surface of 898 m². Figure 2 presents the plan view of the building.

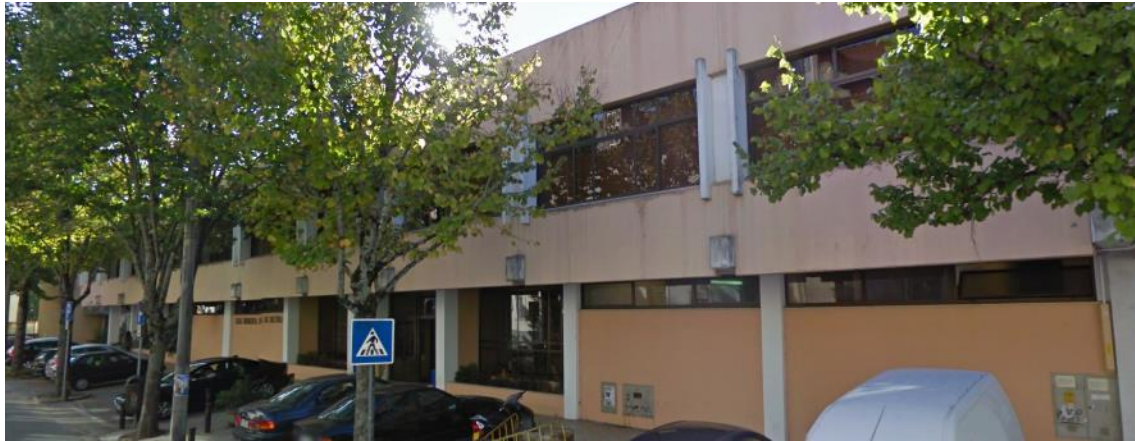
FIGURE 6: MUNICIPAL HOUSE OF CULTURE

The Municipal House of Culture was built in 1991-1993 and opened on October, 26th 1993. Figure 6 presents the front façade of the building. The building is located near to the city centre and near to the University.

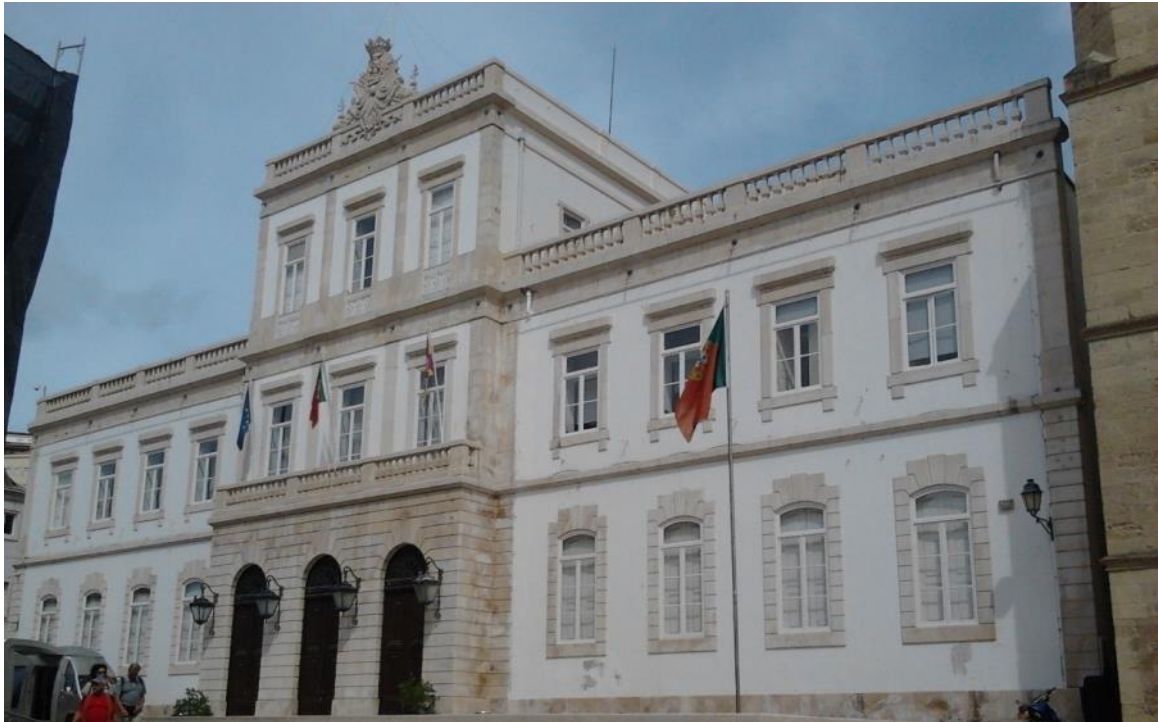
FIGURE 9: COIMBRA TOWN HALL

The Coimbra Town Hall was built after the demolition of part of the old Monastery of Santa Cruz. The demolitions works and construction was carried out mainly between 1876 and 1879, but some construction works were developed gradually until the beginning of century XX. Figure 9 presents the front façade of the building. The building is located in the downtown.

The building has 3 floors and 2 intermediate floors with a total area of about 5880m² with a total used surface of about 3711m² and a volume of 40575m³. The roof is made of ceramic tile and has a surface of 1974m². Figure 10 presents the plan view of the building.
