Cost Efficient Options and Financing Mechanisms
for nearly Zero Energy Renovation
of existing Buildings Stock

DELIVERABLE 2.3

RELATÓRIO SUMARIO DOS OBSTÁCULOS, RISCOS E DIFICULDADES PARA OS ESQUEMAS DE RENOVAÇÃO

Município de Coimbra, Portugal

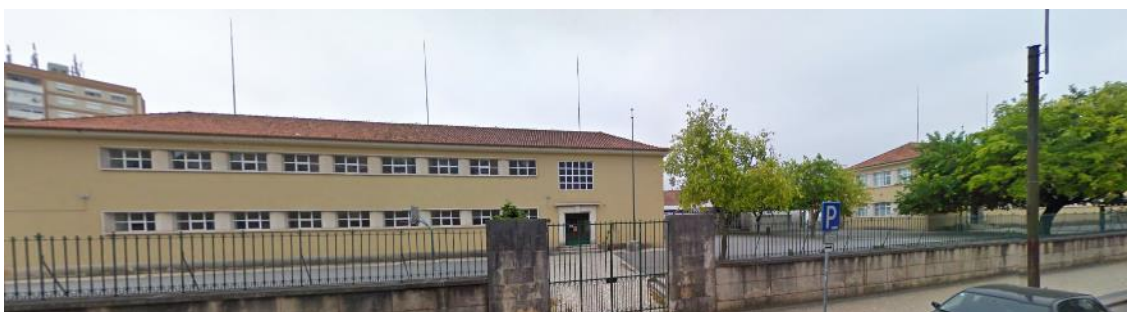
FIGURE 1: ESCOLA BÁSICA DO 1º CICLO DA SOLUM

The Elementary School of Solum (Escola Básica do 1º Ciclo da Solum) was built in the 1950s. Until the 1970s this was an annex school to the teacher training colleges dedicated to pedagogical training. In the 1990s it was converted into an Elementary School. The construction of refectory and a partial renovation of the building was done 10 years ago. Figure 1 presents the front façade of the building. The building is located in the East side of the city, near to the Stadium and a commercial area.

The building is divided in 3 main areas: 2 blocks of classrooms and the refectory. It has total area of about 1655 m² (756 m² in each block and 142 m² in the refectory) and a volume of 6269,21 m³ (2828,19 m³ in each block and 612,84 m³ in the refectory). The roof is of ceramic tile and has a surface of 898 m². Figure 2 presents the plan view of the building.

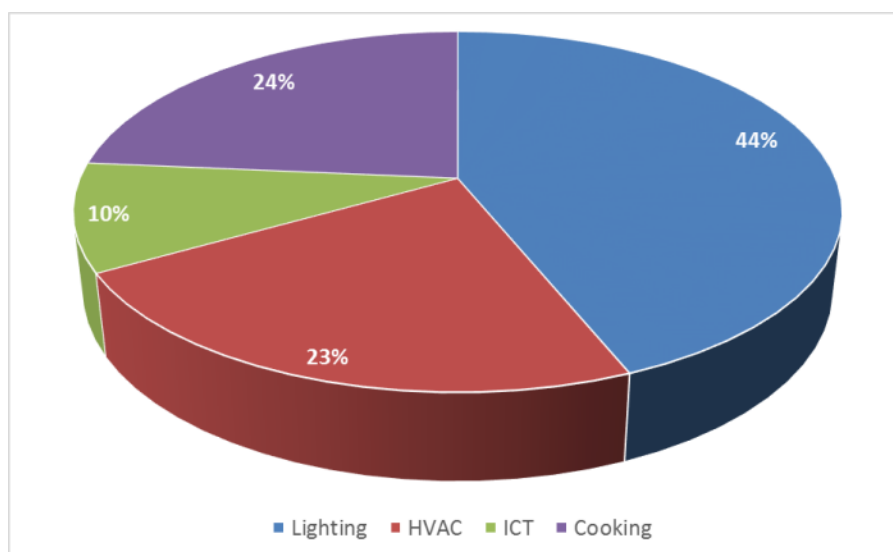
FIGURE 3: DESAGREGAÇÃO DO CONSUMO DE ELETRICIDADE ENTRE USOS, EXCLUINDO O EDIFÍCIO PRE-FABRICADO

In 2013 the building had an electricity consumption of about 30 MWh and an associated cost of about 6,7 k€. Figure 3 presents the disaggregation of electricity consumption between uses.

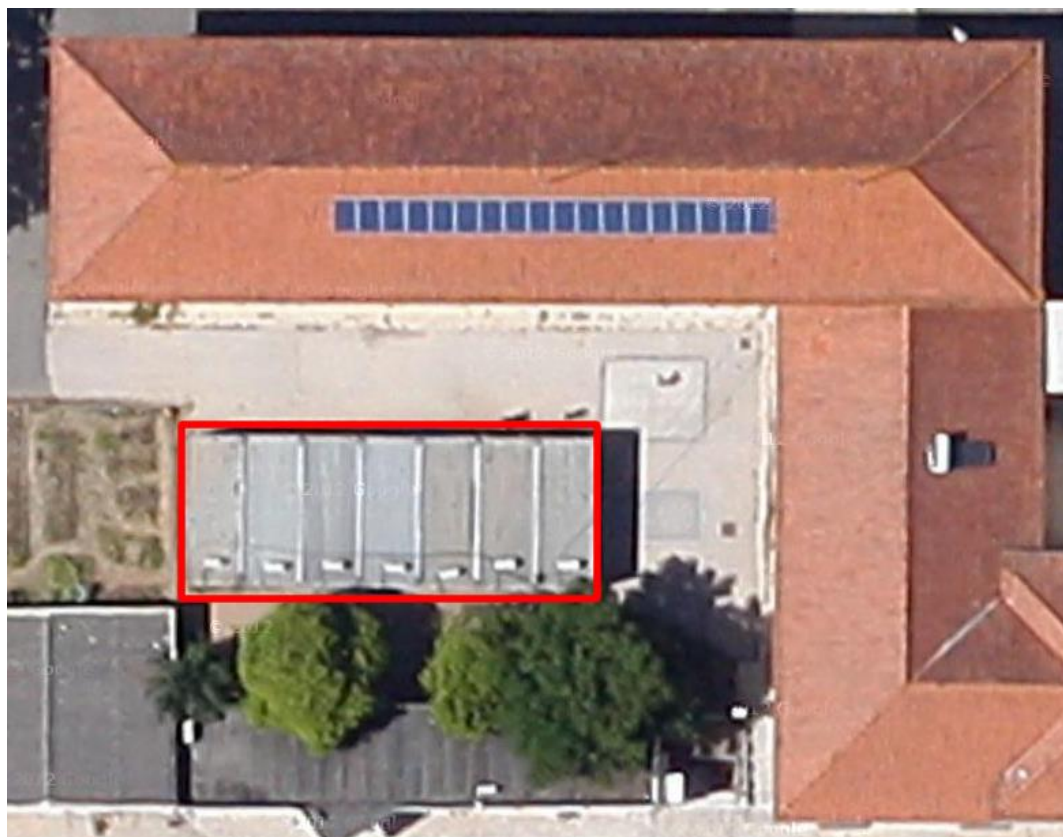
FIGURE 4: PREFABRICATED BUILDING FROM THE FAMILY SUPPORT PROJECT

There are 7 prefabricated buildings in the exterior area of the school (Figure 4). Such buildings are not a permanent construction and do not belong to the Municipality, being managed by the Family Support project. However, they receive electricity from the school (Figure 5) without any individual metering. Therefore, its consumption is included in the total consumption of the building, but such energy consumption cannot be considered as a consumption of the studied building. The consumption of the prefabricated buildings was assessed (considered to be 27% of the total energy consumption) and subtracted from the total considered for the building. This situation can also be a barrier in the future, creating difficulties to a properly monitoring of savings.

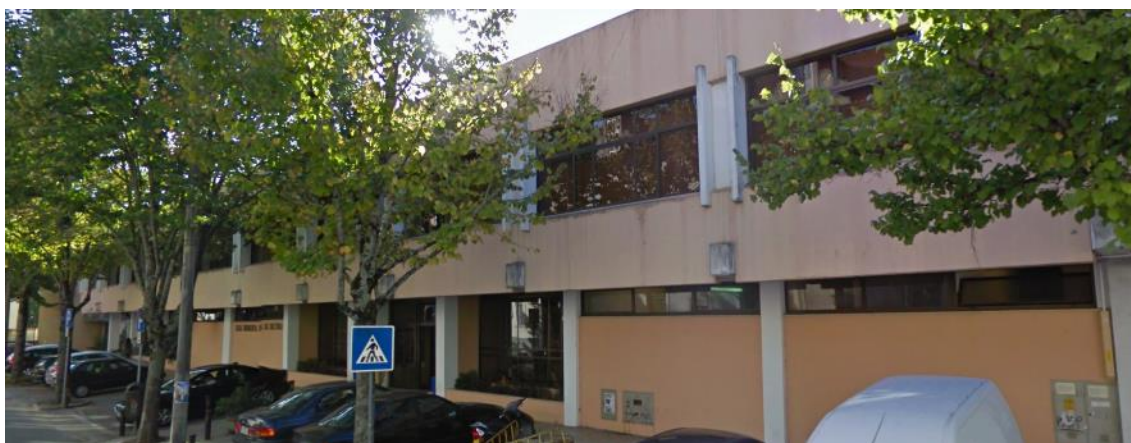
FIGURE 6: MUNICIPAL HOUSE OF CULTURE

The Municipal House of Culture was built in 1991-1993 and opened on October, 26th 1993. Figure 6 presents the front façade of the building. The building is located near to the city centre and near to the University.

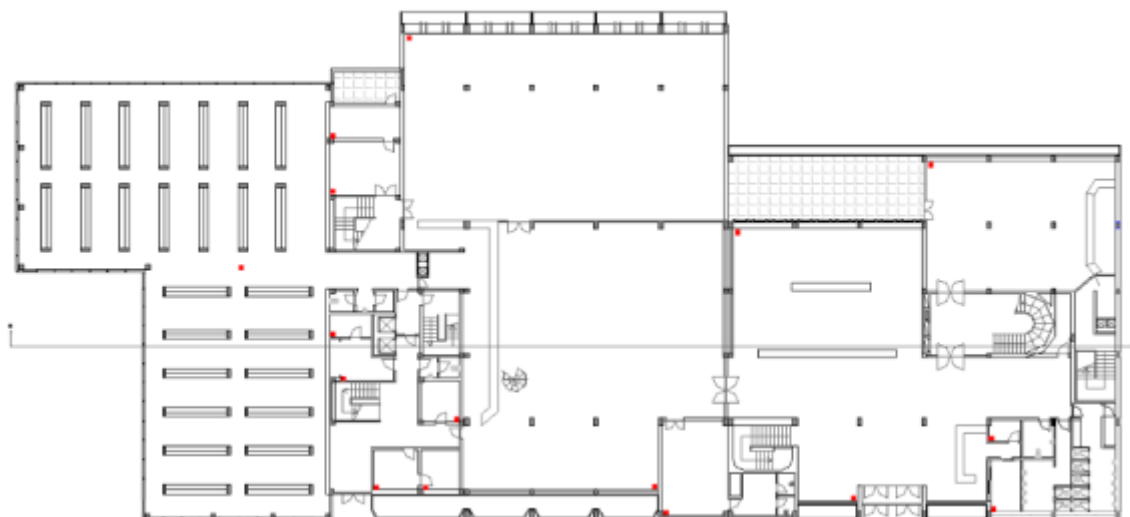
FIGURE 7: PLAN VIEW OF THE MUNICIPAL HOUSE OF CULTURE

The building has 8 floors with a total area of about 13225 m² with a total used surface of about 9862 m² and a volume of 39944 m³. The roof is flat without tiles and has a surface of 2565 m².

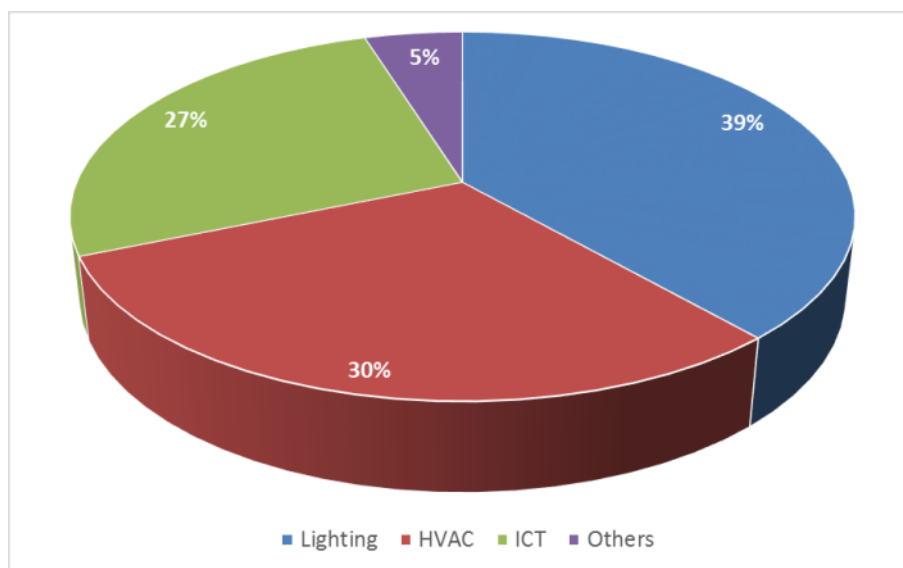
FIGURE 8: DISAGGREGATION OF ELECTRICITY CONSUMPTION BETWEEN USES, EXCLUDING THE REFECTORY

In 2013 the building had an electricity consumption of about 521 MWh and an associated cost of about 84 k€. Figure 8 presents the disaggregation of electricity consumption between uses.

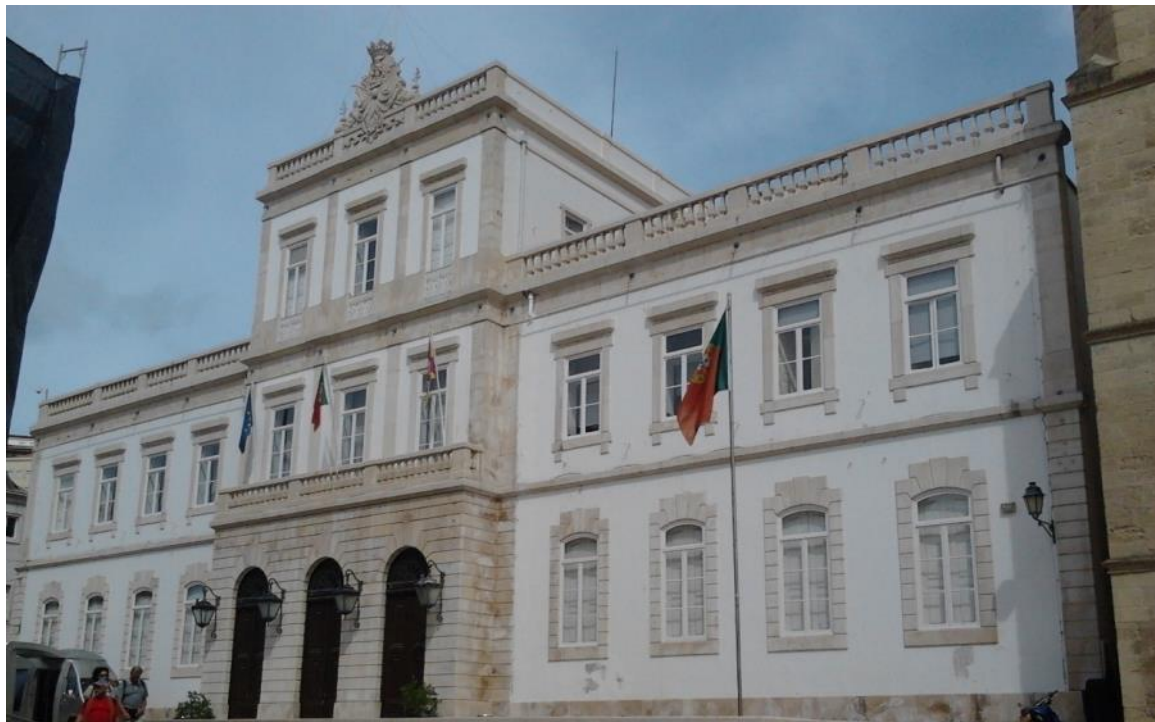
FIGURE 9: COIMBRA TOWN HALL

The Coimbra Town Hall was built after the demolition of part of the old Monastery of Santa Cruz. The demolitions works and construction was carried out mainly between 1876 and 1879, but some construction works were developed gradually until the beginning of century XX. Figure 9 presents the front façade of the building. The building is located in the downtown.

The building has 3 floors and 2 intermediate floors with a total area of about 5880m² with a total used surface of about 3711m² and a volume of 40575m³. The roof is made of ceramic tile and has a surface of 1974m². Figure 10 presents the plan view of the building.

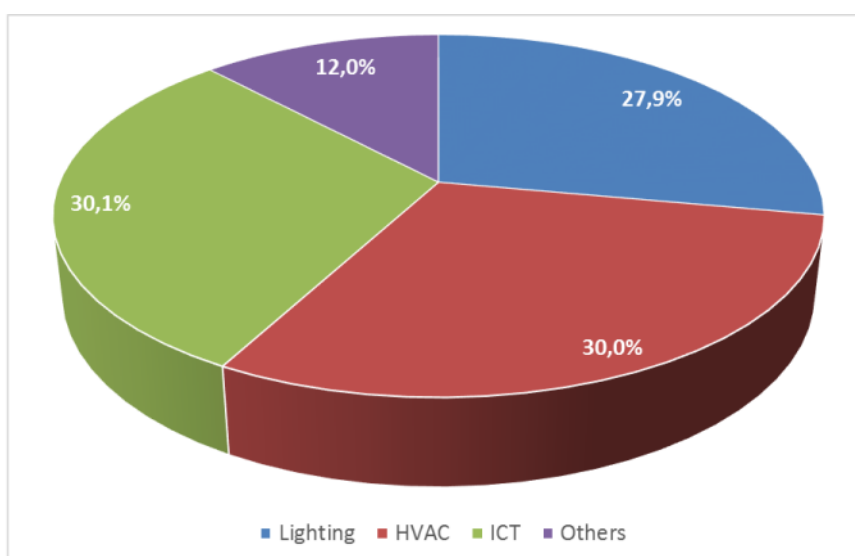
FIGURE 11: DISAGGREGATION OF ELECTRICITY CONSUMPTION BETWEEN USES

In 2013 the building had an electricity consumption of about 305 MWh and an associated cost of about 60 k€. Figure 11 presents the disaggregation of electricity consumption between uses.
