Cost Efficient Options and Financing Mechanisms for nearly Zero Energy Renovation of existing Buildings Stock

REPORT SUMMARIZING THE OBSTACLES, RISKS AND DIFFICULTIES FOR THE RENOVATION SCHEMES

Municipality of Messina, Italy

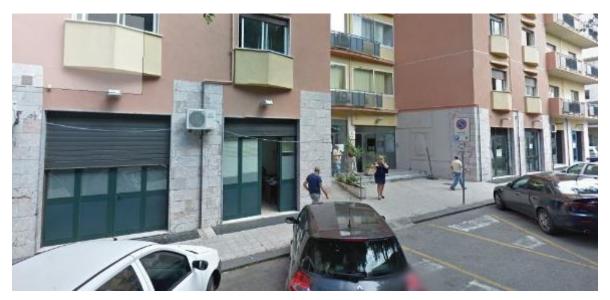
FIGURE 7 - GROUND FLOOR

Palazzo Satellite is a municipal building, in which there are multiple functions of public utility. On the ground floor (Figure 7) there is the access to the building with the hall and reception. All rooms are now used as municipal offices, with the exception of bathrooms and deposits.

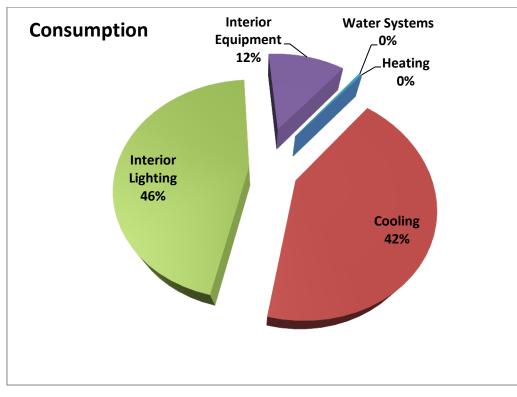
FIGURE 9 - CONSUMPTION

Electricity [kWh]	Natural Gas [kWh]	Additional Fuel [kWh]	District Cooling [kWh]	District Heating [kWh]	Water [m3]
Heating	0.00	0.00	0.00	0.00	2714.76	0.00
Cooling	0.00	0.00	0.00	790256.80	0.00	0.00
Interior Lighting	852503.17	0.00	0.00	0.00	0.00	0.00
Exterior Lighting	0.00	0.00	0.00	0.00	0.00	0.00
Interior Equipment	222119.61	0.00	0.00	0.00	0.00	0.00
Water Systems	0.00	0.00	0.00	0.00	5349.45	143.97
Refrigeration	0.00	0.00	0.00	0.00	0.00	0.00
Generators	0.00	0.00	0.00	0.00	0.00	0.00
Total End Uses	1074622.78	0.00	0.00	790256.80	8064.20	143.97

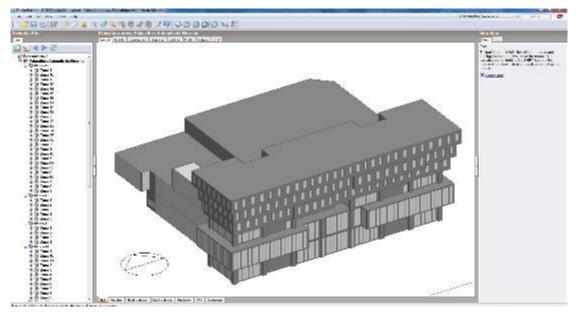
FIGURE 15 - HOME SCREEN OF THE SOFTWARE

For the simulation of Palace of Culture of Messina with Design Builder (Figure 13), the building was divided into 11 blocks (named 11,12,13,14,16,2,3,4,5,6,7) (Figure 14).

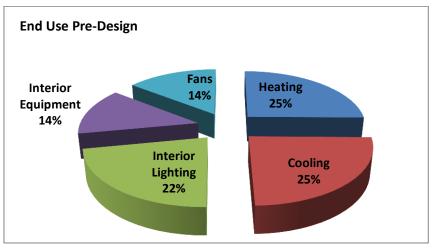
FIGURE 16 - END USE CONSUMPTION PRE DESIGN

Electricity [kWh]
Heating	223362.48
Cooling	217049.09
Interior Lighting	196858.13
Interior Equipment	120275.15
Fans	127924.50
Total End Uses	885469.36
