Cost Efficient Options and Financing Mechanisms for nearly Zero Energy Renovation of existing Buildings Stock

DELIVERABLE 2.3

REPORT SUMMARIZING OBSTACLES, RISKS AND DIFFICULTIES FOR THE RENOVATION SCHEMES

Municipality of Alimos, Greece

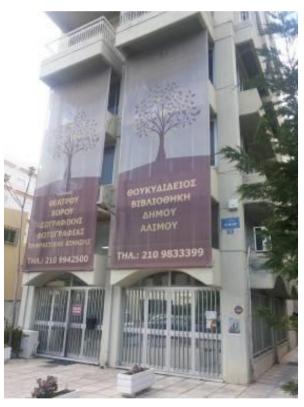
FIGURE 4: ALIMOS MUNICIPAL LIBRARY – MAIN FAÇADE OF THE BUILDING (SOUTHEAST SIDE)

The building (Figure 4) was constructed in 1984. It is a five-storey building with a basement. The Municipality rents the first three storeys and the basement and houses the Municipal Library, offices, school activities and dancing courses. The rest of the building is residential.

The building construction is typical of the period and region. It consists of double brick walls and reinforced concrete for the load bearing structure. The walls are insulated with 5 cm of extruded polystyrene placed in between the two brick layers. The roof slab is insulated also with 8 cm extruded polystyrene while there is a mineral fibre suspended ceiling in the office space. In all working areas there are opening windows with double glazing in aluminium frame.

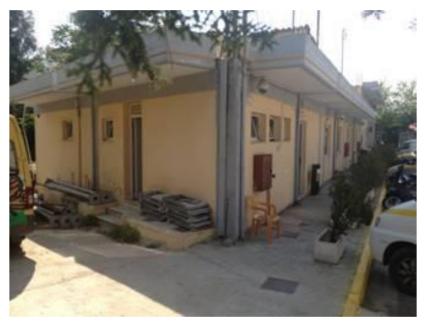
FIGURE 8: ALIMOS MUNICIPAL OFFICES – MAIN FAÇADE OF THE BUILDING (NORTHEAST SIDE)

The building (Figure 8) was constructed in 1986 and is owned by the Municipality of Alimos. It houses the environmental and hygiene services of the Municipality.

The building construction is typical of the period and region. It consists of double brick walls and reinforced concrete for the load bearing structure. The walls are insulated with 5 cm of extruded polystyrene placed in between the two brick layers. The roof slab is insulated also with 6 cm extruded polystyrene while there is a mineral fibre suspended ceiling in the office space. In all working areas there are opening windows with double glazing in aluminium frame. Figure 9 presents the plan view of the building.

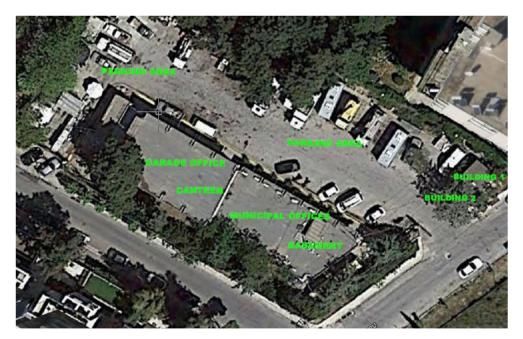
FIGURE 10: ALIMOS MUNICIPAL OFFICES SURROUNDING FREE SPACE

A parking area for municipality's refuse collector trucks is located on the northeast and northwest sides of the building. The total area of the free space around the building is 2.000 m^2 .
